FLORIDA ENGINEERING LLC

## RESIDENTIAL REPORT

Kelly Greens Terrace Condominium VII Association, Inc.

Phase One Milestone Inspection

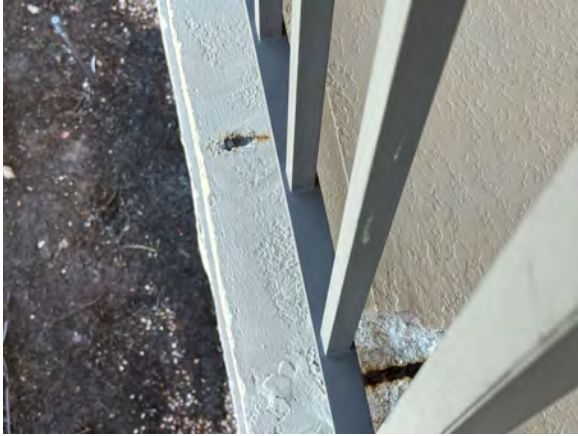
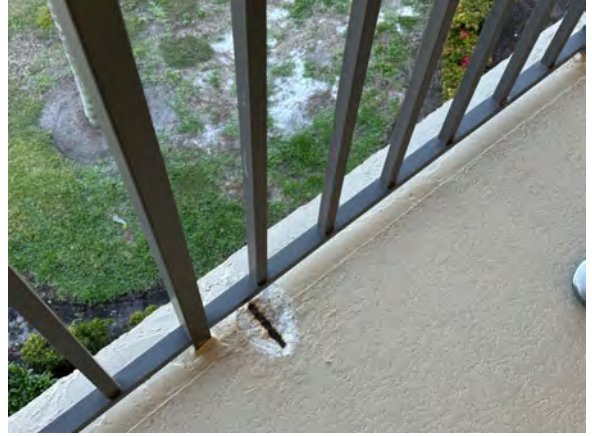
1.o.1

1. Exposed rebar near Units 724-726
2. Spalling on the face and underside of the majority of the balconies, Unit 729 has the most significant damage

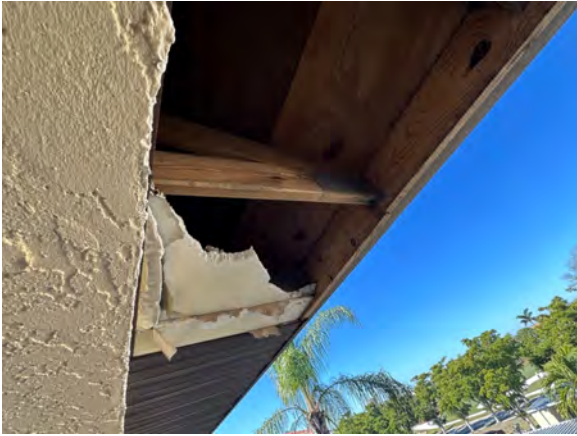
1.p.1

1. Soffits are open and have exposed lumber
2. Minor spalling on top of slab in front of Units 711 and 714
3. Minor cracking and possible spalling on decking in multiple locations
4. Exposed rebar on top of slab near Units 730 & 729
5. Minor cracking in column near Unit 721 & 727
6. Minor cracking in top of slab through the column near Units 725, 724, and 711
7. Exposed wire lathe in beams near Units 705 and 701
8. Various spots of missing sections of downspouts
9. Minor cracking in dividing wall above roof
10. Minor spalling on edge of slab in front of Units 726-729, 722, 721, 716, 717, and 719
