## **TRADITIONAL RESERVE STUDY STRUCTURAL INTEGRITY RESERVE STUDY**

**Kelly Green Terrace 7**  
**12170 Kelly Sands Way**  
**Fort Myers, Florida 33908**

**Project Number 2333976**

May 15, 2024

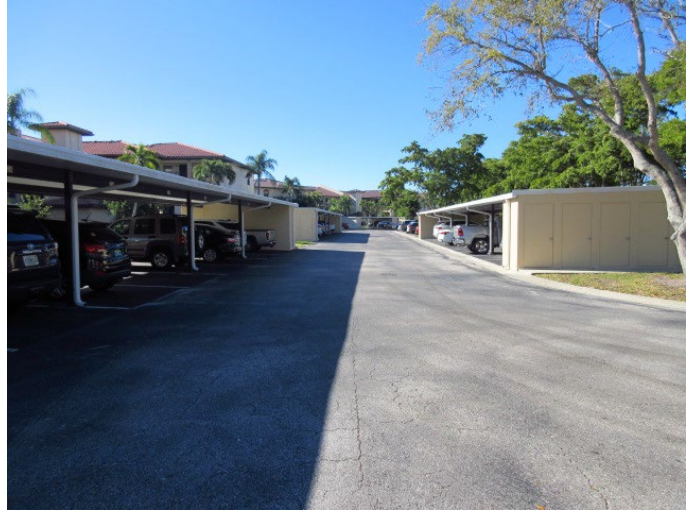
## PHOTO 4

| Item | Description/Observations/Comments |
|---|---|
| <b>Parking/Paving</b> | <p>The interior drive and parking areas are paved with asphalt. There are approximately 70 spaces provided, of which 35 spaces are in steel-framed carports and the remaining in an open surface lot.</p> <p><b>The parking and driveway areas were noted to be in good condition, appeared to have been resurfaced approximately 8 to 9 years ago. Periodic crack-sealing, sealcoating, and striping are recommended during the evaluation period. Funds have been spread throughout Replacement Reserves Cost Estimate Table, adopting the straight-line accounting method to ensure the availability of funds at the end of the replaced element's EUL, beyond the evaluation period of this assessment.</b></p> <p><b>In addition, based on the EUL of 25 years, funds for asphalt pavement resurfacing (including sidewalks) have been spread throughout Replacement Reserves Cost Estimate Table, adopting the straight-line accounting method to ensure the availability of funds at the end of the replaced element's EUL, beyond the evaluation period of this assessment.</b></p> |

GENERAL VIEW OF PARKING AND PAVEMENT

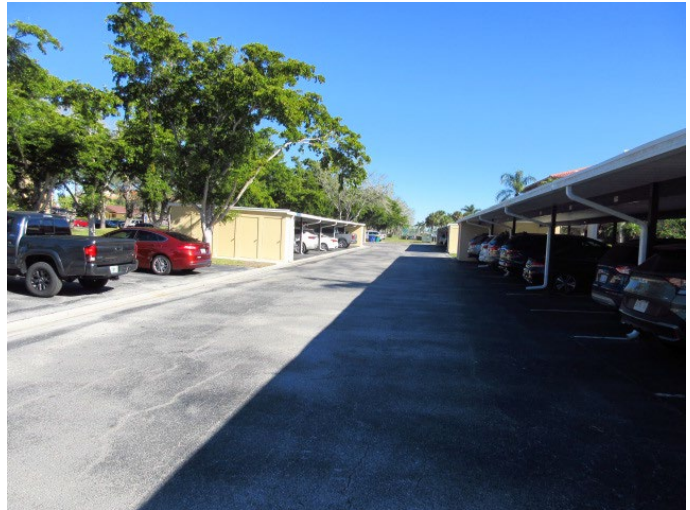
## PHOTO 5

GENERAL VIEW OF PARKING AND PAVEMENT

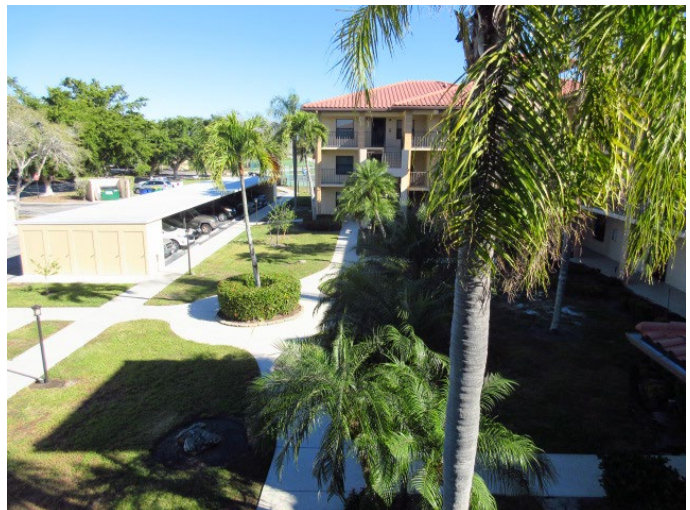
## PHOTO 6

| Item | Description/Observations/Comments |
|---|---|
| <b>Landscaping</b> | <p>Landscaping at the Property includes various mature trees, bushes, and lawn. An automatic underground irrigation system is provided.</p> <p><b>Landscaping appears to be in good condition, with no significant deficiencies noted. Funds for upkeep and upgrades of landscaping is considered part of routine maintenance.</b></p> |

VIEW OF LANDSCAPING

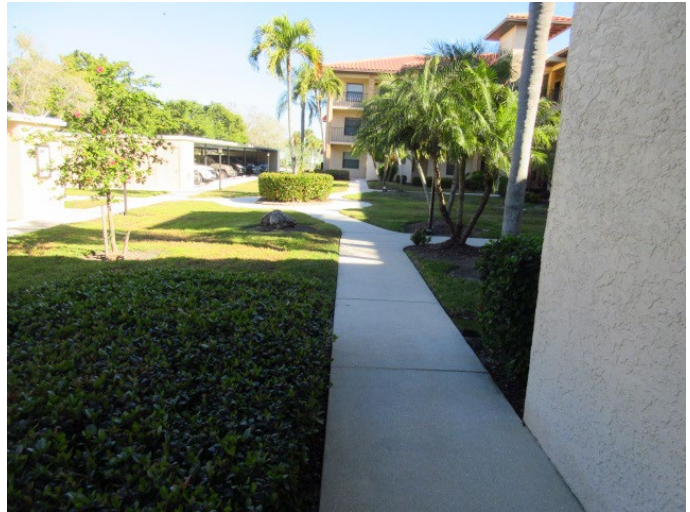
## PHOTO 7

| Item | Description/Observations/Comments |
|---|---|
| <b>Sidewalks</b> | <p>Property pedestrian walkways and flatwork consist of a combination of asphalt and concrete.</p> <p><b>The sidewalks appeared to be in good condition, requiring routine maintenance over the evaluation period.</b></p> |

GENERAL VIEW OF PEDESTRIAN WALKWAY

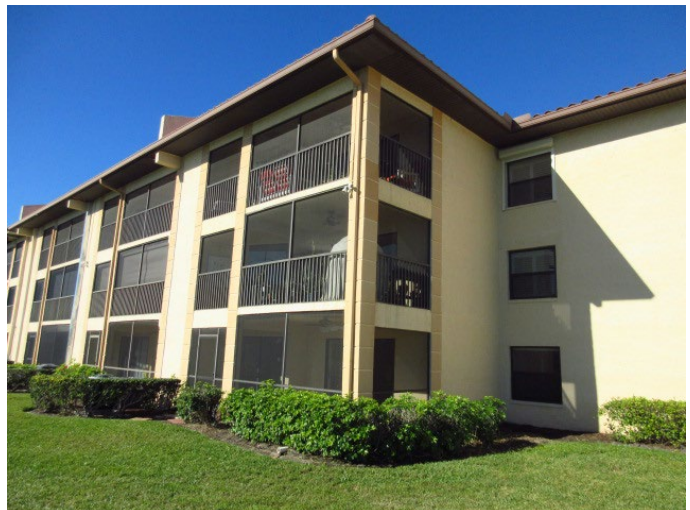
## PHOTO 9

| Item | Description/Observations/Comments |
|---|---|
| Exterior Walls | <p>The exterior walls typically consist of concrete masonry unit (CMU) construction finished with painted stucco.</p> <p><b>The exterior walls were noted to be in generally good condition, with no significant deficiencies noted. Scattered areas of cracking and spalling were noted at several locations, requiring repair. Funds have been allocated in the Immediate Repairs Cost Estimate Table.</b></p> <p><b>The exterior walls were reportedly last repainted and waterproofed mor than 10 years ago. Based on the EUL of 10 years, repainting, waterproofing and periodic stucco restoration of the exterior surfaces are recommended early in the evaluation period. Funds have been spread throughout the Replacement Reserves Cost Estimate Table, adopting the straight-line accounting method to ensure the availability of funds at the end of the replaced element's EUL, beyond the evaluation period of this assessment.</b></p> |

VIEW OF BUILDING EXTERIOR FINISHES

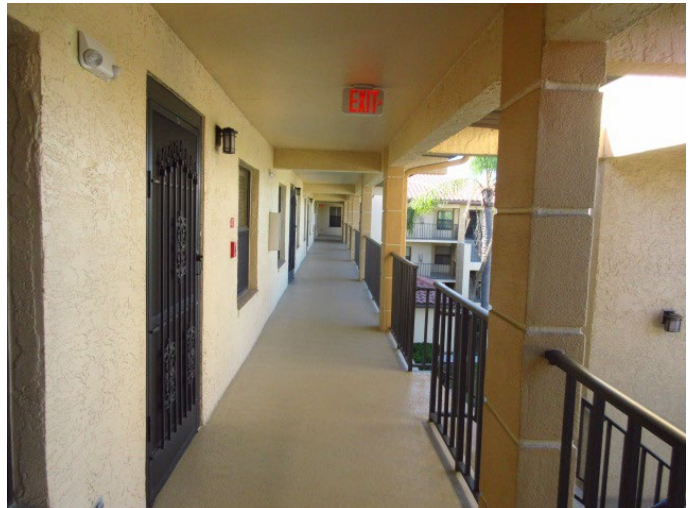
## PHOTO 12

| Item | Description/Observations/Comments |
|---|---|
| | <p><b>The elevated walkways appeared to be in good condition. These components are generally addressed in conjunction with the exterior façade painting and waterproofing applications.</b></p> |

VIEW OF ELEVATED WALKWAY

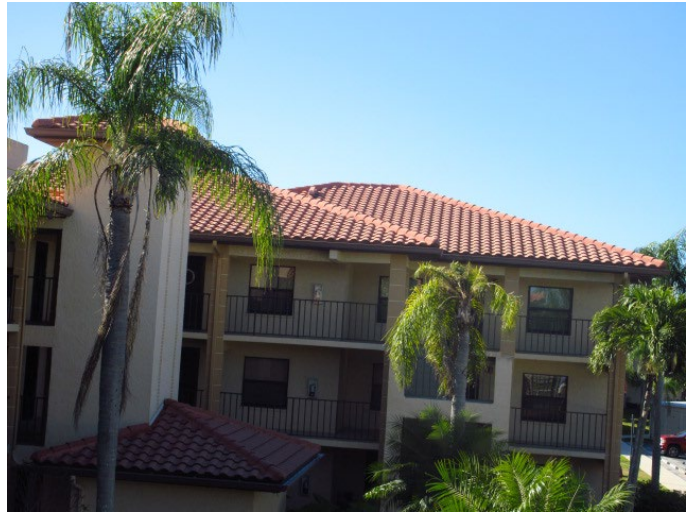
**PHOTO 13**

| Item | Description/Observations/Comments |
|---|---|
| Roof | <p>The roof covering consists of a wood-framed pitched tile system.</p> <p><b>The roof covering and associated eaves soffit were noted to have sustained damages during the most recent hurricane and are currently awaiting insurance claim resolution. Funds for roof replacement have been allocated have been allocated in the Immediate Repairs Cost Estimate Table.</b></p> <p><b>In addition, based on the EUL of 35 years, funds for roof replacement have been spread throughout the Replacement Reserves Cost Estimate Table, adopting the straight-line accounting method to ensure the availability of funds at the end of the replaced element's EUL, beyond the evaluation period of this assessment.</b></p> |

VIEW OF ROOF COVERING

| Item No. | Item Description | Quantity | Unit | Cost | Totals | Existing Balance | Remaining Funds | Comments |
|---|---|---|---|---|---|---|---|---|
| 2 | Roof covering - pitched | 17,500 | SF | \$30 | \$525,000 | | | Replace roof covering and eaves soffit |

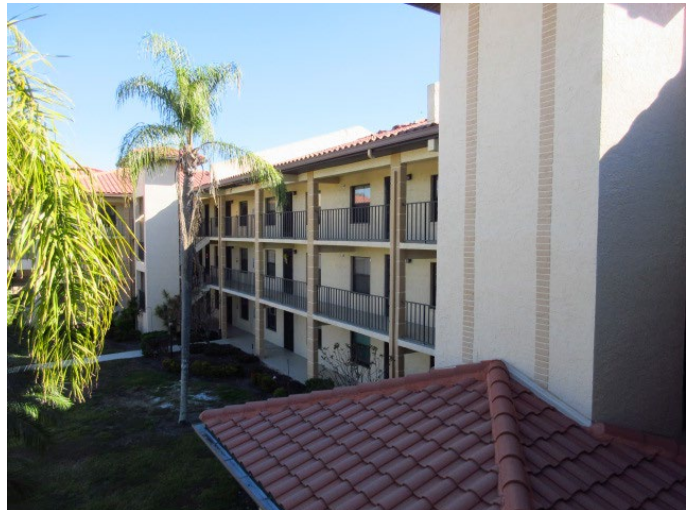
**PHOTO 14**

VIEW OF ROOF COVERING

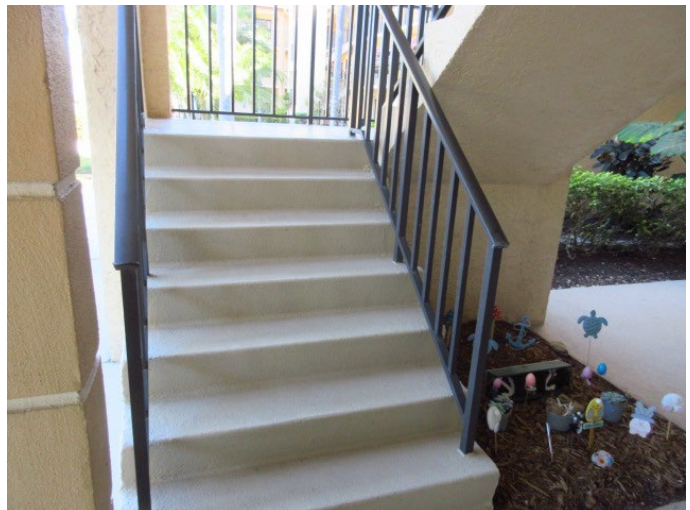
**PHOTO 15**

| Item | Description/Observations/Comments |
|---|---|
| Stairs | <p>The stairs consist of poured concrete with closed risers and aluminum railing.</p> <p>The stairs appeared to be in generally good condition, with no significant deficiencies noted, requiring routine maintenance during the evaluation period. Stairs-related repairs and upkeep are recommended implemented in conjunction with the exterior walls painting and waterproofing applications during the evaluation period.</p> |

GENERAL VIEW OF EXTERIOR STAIRS

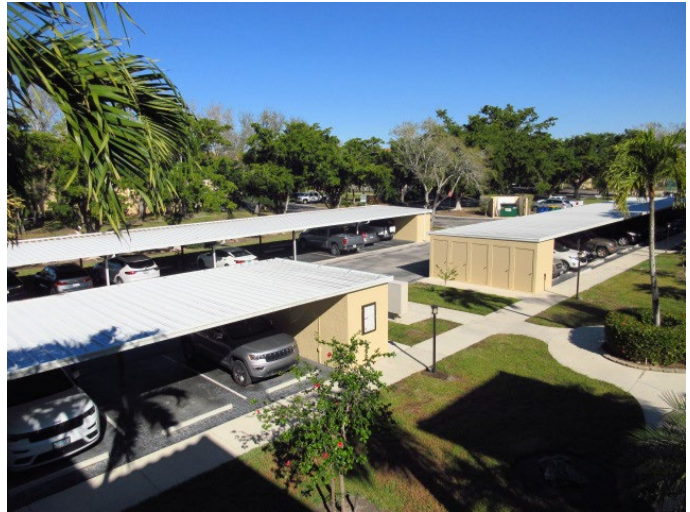
**PHOTO 16**

| Item | Description/Observations/Comments |
|---|---|
| | <p><b>The carports appeared to be approximately 10 years old and noted to be in generally good condition. Based on the EUL of 30 years, funds for replacement have been spread throughout the Replacement Reserves Cost Estimate Table, adopting the straight-line accounting method to ensure the availability of funds at the end of the replaced element's EUL, beyond the evaluation period of this assessment.</b></p> |

VIEW OF CARPORTS

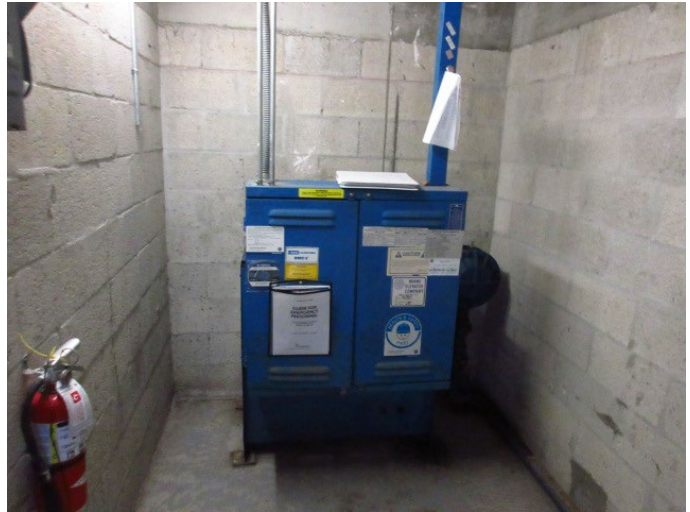
## PHOTO 19

| Item | Description/Observations/Comments |
|---|---|
| Elevators | <p>The Property is equipped with one hydraulic elevator, rated at 2,100 pounds of load capacity, providing access to all floors.</p> <p>The elevator controls were noted to be of older installation. Elevator controls typically have an EUL of 25 years. Funds for component and control upgrades / modernization have been spread throughout the Replacement Reserves Cost Estimate Table, adopting the straight-line accounting method to ensure the availability of funds at the end of the replaced element's EUL beyond the evaluation period of this assessment.</p> |

VIEW OF ELEVATOR EQUIPMENT

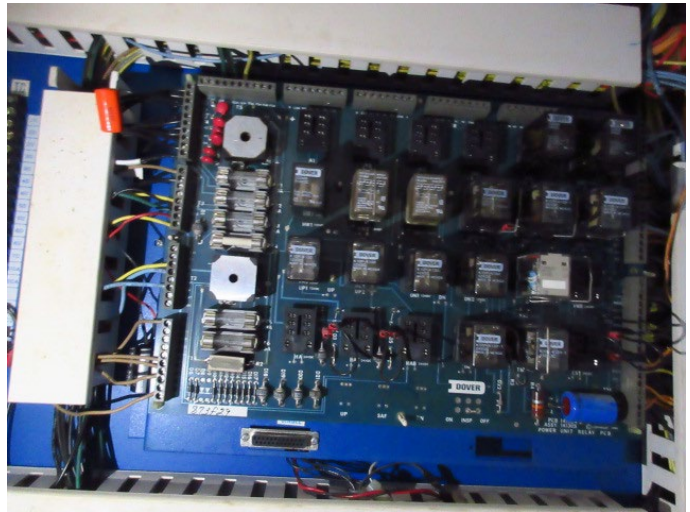
## PHOTO 20

VIEW OF ELEVATOR EQUIPMENT

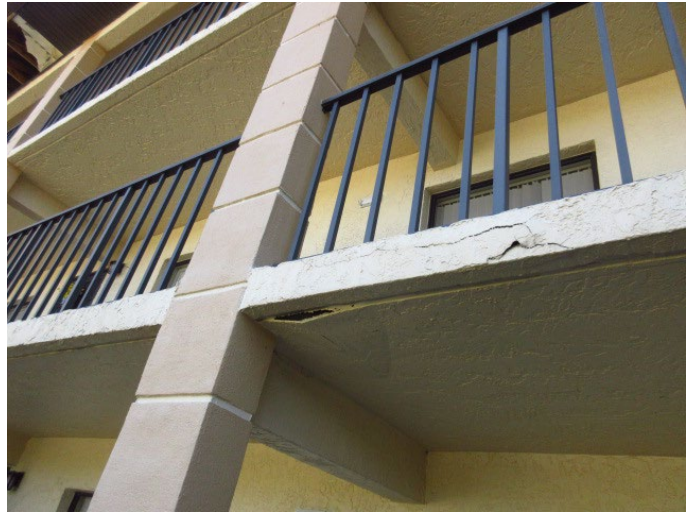
**PHOTO 25**

VIEW OF DAMAGED STUCCO

| Item No. | Item Description | Quantity | Unit | Cost | Totals | Existing Balance | Remaining Funds | Comments |
|---|---|---|---|---|---|---|---|---|
| 1 | Exterior walls | 1 | LS | \$15,000 | \$15,000 | | | Repair scattered damages - cracking and spalling |

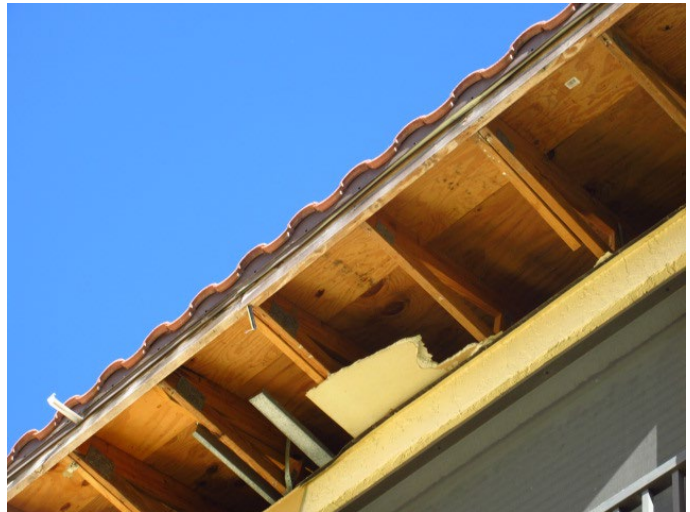
**PHOTO 26**

VIEW OF DAMAGED STUCCO

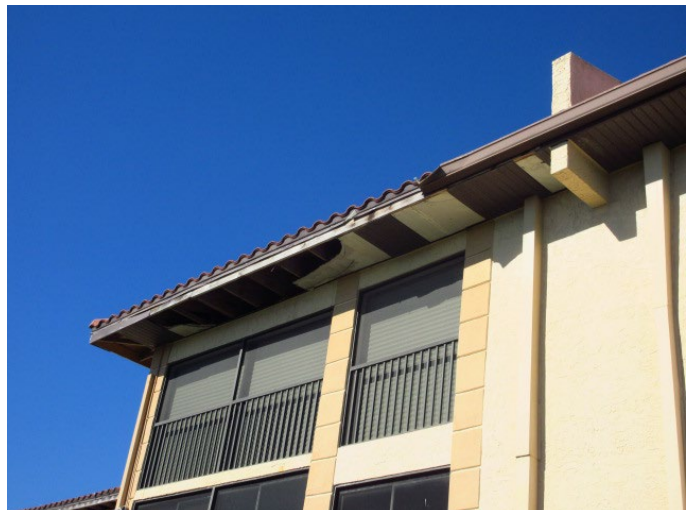
**PHOTO 27**

VIEW OF DAMAGED STUCCO
