# Inspection Report

12170 Kelly Sands Way Apt 717  
Fort Myers FL 33908

## MEF Home Inspections LLC

Condominium

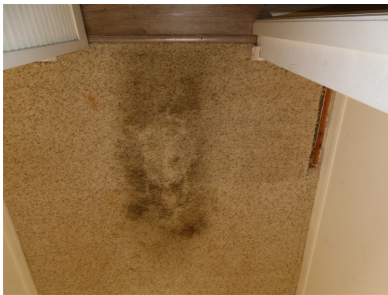
**2.0 Item 1 (Picture)**  
Master bathroom closet

Carpets in the home had areas of staining or discoloration. Before the expiration of your Inspection Objection Deadline you may wish to consult with a qualified contractor to discuss options and costs for repair or replacement.

Carpets in the home had areas of staining or discoloration. Before the expiration of your Inspection Objection Deadline you may wish to consult with a qualified contractor to discuss options and costs for repair or replacement.

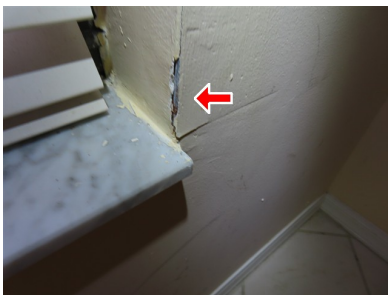
**2.1 Item 1 (Picture)**

(1) Minor drywall damage around window at kitchen.

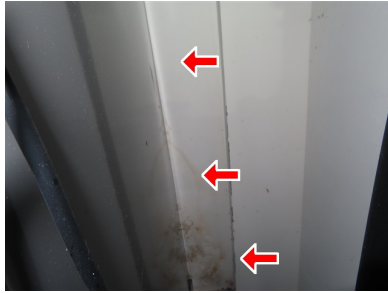
2.1 Item 2 (Picture)

(2) Stains on the walls in the air handler closet appeared to be the result of moisture damage from condensation from air handler. The moisture meter showed no elevated moisture levels in the affected areas at the time of the inspection. This condition indicated that either the source of moisture had been corrected, or the source of moisture was intermittent or seasonal, in which case damage could continue until conditions allowed the source to be identified and corrected..

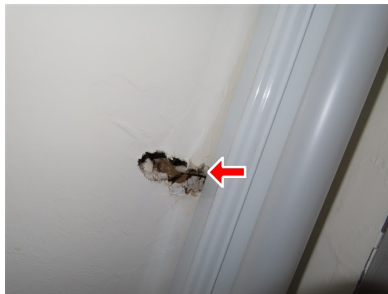
2.2 Item 1 (Picture)

A hole in the laundry room ceiling should be patched.

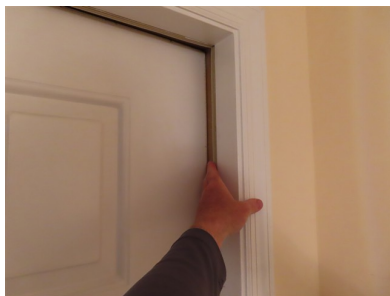
2.6 Item 1 (Picture)

The front is binding on the jamb and was difficult to close. The Inspector recommends service by a qualified contractor.

The front is binding on the jamb and was difficult to close. The Inspector recommends service by a qualified contractor.

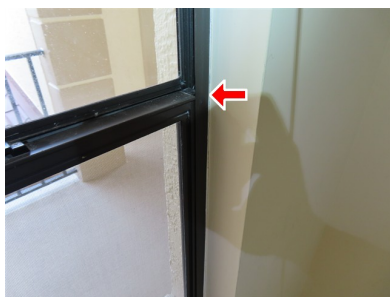
2.7 Item 1 (Picture)

(1) A window in the kitchen was difficult to operate and needed maintenance to window balances. The Inspector recommends service by a qualified contractor.

(1) A window in the kitchen was difficult to operate and needed maintenance to window balances. The Inspector recommends service by a qualified contractor.

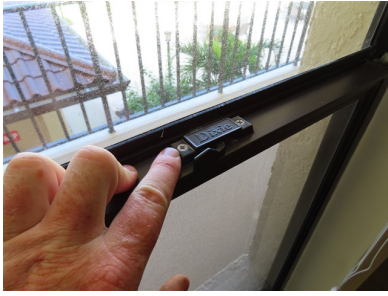
**2.7 Item 2 (Picture)**  
1st shared bedroom

(2) Windows in the home had inoperable locking hardware. The Inspector recommends service by a qualified contractor.

(2) Windows in the home had inoperable locking hardware. The Inspector recommends service by a qualified contractor.

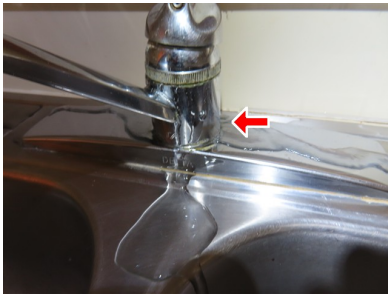
**2.9 Item 1 (Picture)**

(1) The faucet of the sink in the kitchen leaked at its base when water was turned on. This typically indicates that a seal needs replacement.

- (1) The faucet of the sink in the kitchen leaked at its base when water was turned on. This typically indicates that a seal needs replacement.
- (2) The faucet of the sink at the wet bar leaked at its base when water was turned on. This typically indicates that a seal needs replacement.

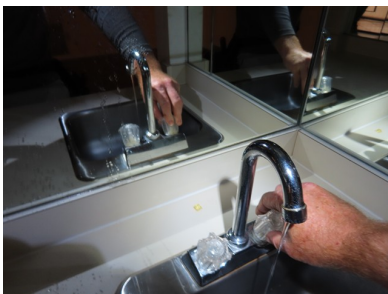
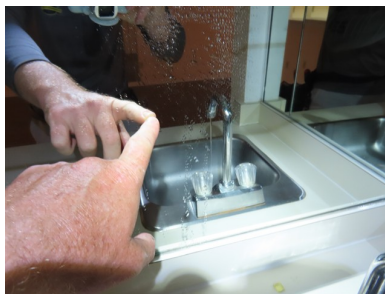
**2.9 Item 2 (Picture)**

(2) The faucet of the sink at the wet bar leaked at its base when water was turned on. This typically indicates that a seal needs replacement.

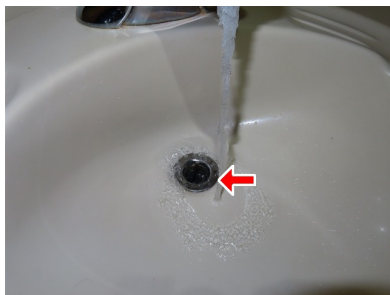
3.4 Item 1 (Picture)

(1) Sink stopper missing at master bathroom sink.

- (1) Sink stopper missing at master bathroom sink.
- (2) Inspector observed minor corrosion around supply line valve at 1st shared bathroom sink.

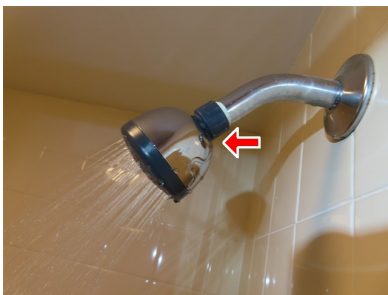
3.6 Item 2 (Picture)

(2) In the master bathroom, the showerhead connection leaked when the shower was operated. The inspector recommends service by a qualified plumbing contactor.

- (1) Grout maintenance needed at shower tiles in master bathroom.
- (2) In the master bathroom, the showerhead connection leaked when the shower was operated. The inspector recommends service by a qualified plumbing contractor.

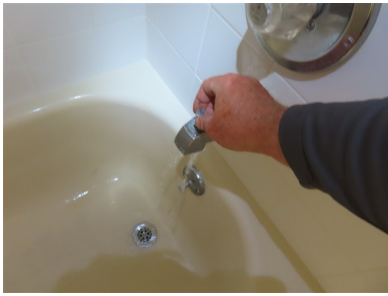
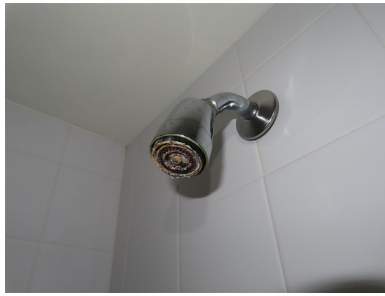
**3.7 Item 1 (Picture)**

In the 1st shared bathroom, the diverter valve was inoperable or did not operate correctly (the diverter is the valve that diverts water from the tub spout to the shower head). The Inspector recommends service by a qualified contractor.

In the 1st shared bathroom, the diverter valve was inoperable or did not operate correctly (the diverter is the valve that diverts water from the tub spout to the shower head). The Inspector recommends service by a qualified contractor.

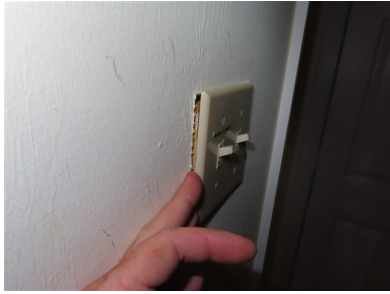
5.17 Item 1 (Picture)

An electrical switch in the 1st shared bedroom was improperly secured. Switches should be securely installed to prevent fire, shock and/or electrocution hazard. The Inspector recommends correction by a qualified electrical contractor.

An electrical switch in the 1st shared bedroom was improperly secured. Switches should be securely installed to prevent fire, shock and/or electrocution hazard. The Inspector recommends correction by a qualified electrical contractor.

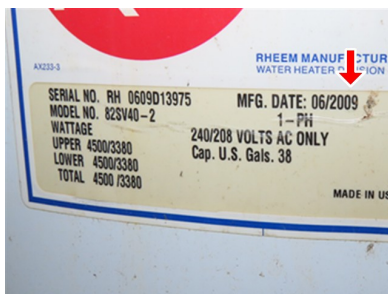
6.2 Item 2 (Picture)

(2) The water hear was past its warranty expiration date and may need to be replaced soon.

- (1) Water heater exhibited signs off corrosion at top of tank from previous leakage.
- (2) The water heater was past its warranty expiration date and may need to be replaced soon.
